A NEW APPLICATION OF THE HYBRID PAVEMENT TO THE AGED CONCRETE PAVEMENT OF CHUO EXPRESSWAY

Naoki NAKASEKO

Hiroyuki YAMAMOTO

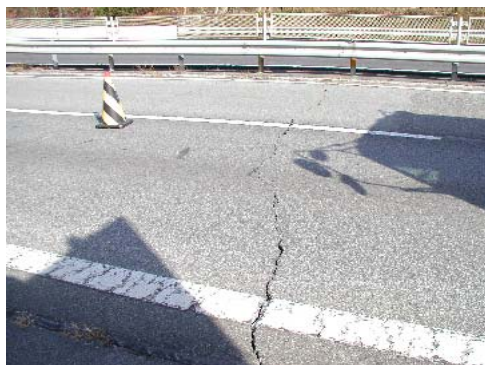
Figure 2: The outbreak situation of the crack

Over 30 years has passed since this section opened. Therefore, the damages of crack and faulting of joint are occurred on pavement slabs. (Figure 2 and Figure 3)

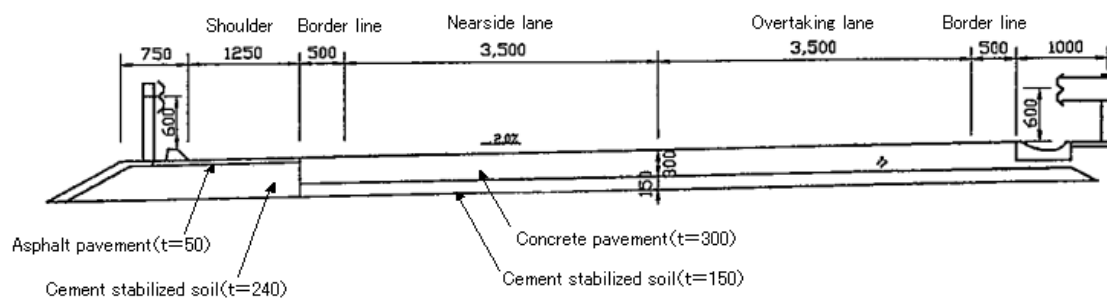
Figure 4: Typical cross-section of the concrete

Figure 4 shows typical cross-section of the concrete pavement. Roadway area and side margin strip are concrete pavement, and shoulder is the asphalt pavement.

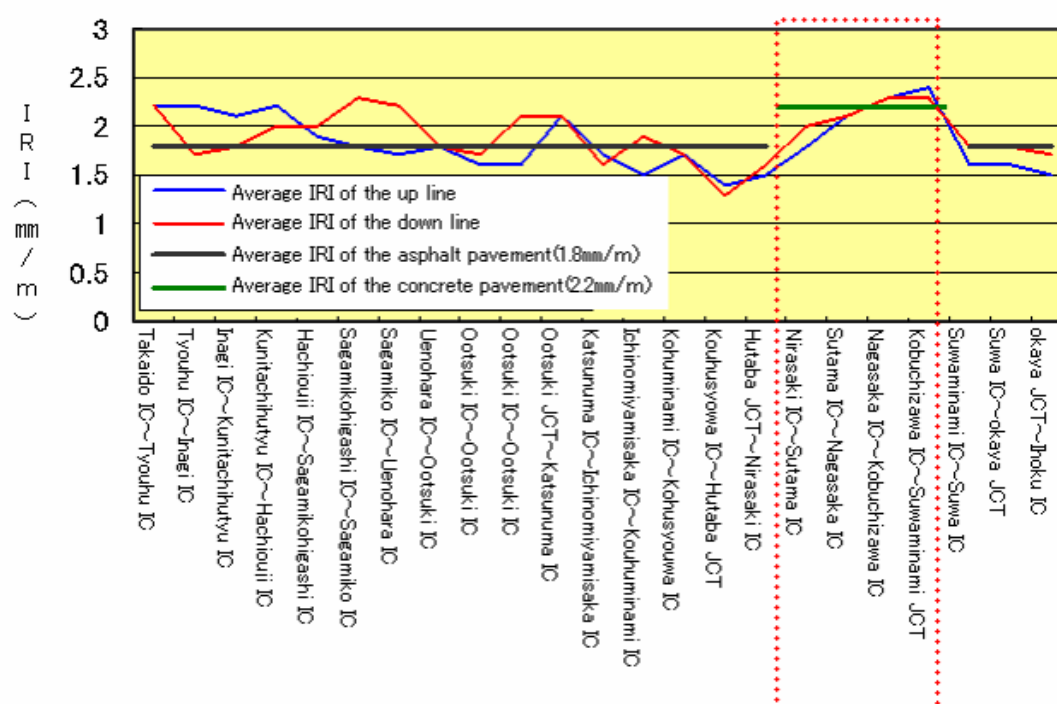
Figure 4: IRI according to IC section

IRI value is 2.2 mm/m on the average of the concrete pavement section It is 1.8 mm/m on the average of the asphalt pavement section. In addition, the point more than 4.0mm/m was confirmed partially, too.

According to the result of a rideability examination performed in the past, 2.2 mm /m is the same level as road condition in which more than 50% of the subject begin to feel worse.

Table 1 shows that a road surface property, and Figure 5 shows the IRI value (International Roughness Index) of the existing concrete pavement.

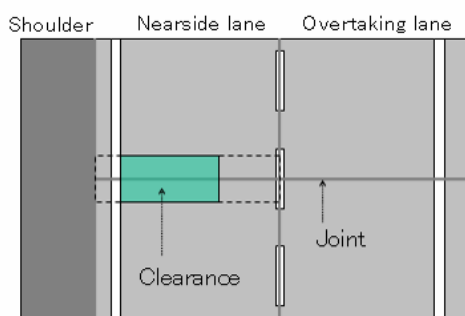
Figure 7: Location map of field investigation

The committee decided on repair of the joint of the concrete pavement with barstich. The existing slip bar is expected damage if load transmissibility becomes less than 65% from past examples. Therefore, a field investigation was carried out about a point of 42%, 64%, and 82%.

As a result, four slip bars among five were broken in 42% and 64% point of load transmissibility. On the other hand, one slip bar was broken in 82% and 77%.

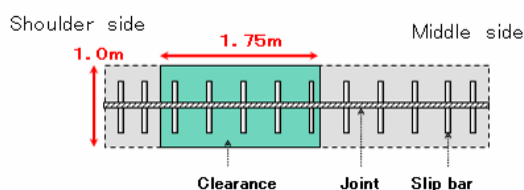
Figure 8: Arrangement of slip bar

As a result of this field investigation, barstich is adopted the existing concrete pavement whose load transmissibility is less than 70%. (Figure 7 and Figure 8 and Figure 9)

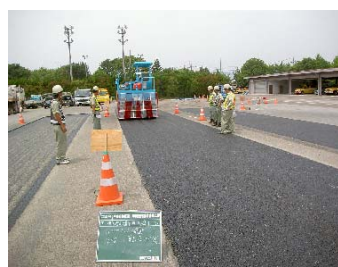
Figure 11: Test pavement (High improved and high)

The result of the test pavement with high improved binder had run-off of asphalt and flush.

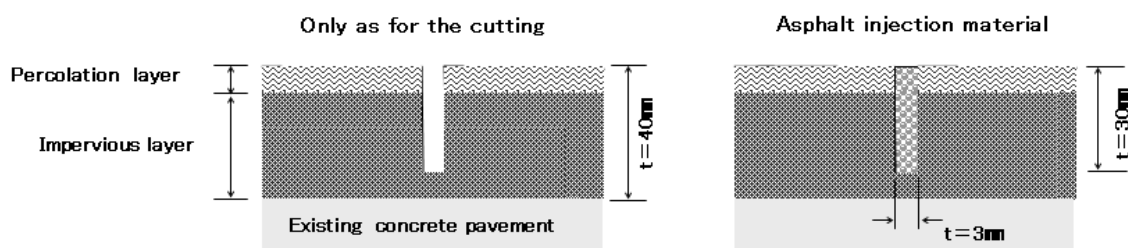
Figure 14: Diagrammatic illustration of joint

Setting up cutting joint (30mm in depth and 3mm in width) for second layer of overlay is more effective from current experience. However the influence by the rainwater to penetrate into joints of first layer of hybrid pavement is apprehended.

Figure 14 shows the comparison to install three kinds of materials with different elastic strength asphalt injection material that prevent from penetration of rainwater and corner cracks of concrete pavement by trial field.

As a result of the trial, the injection material on real fields does not needed so far, therefore there are no change.

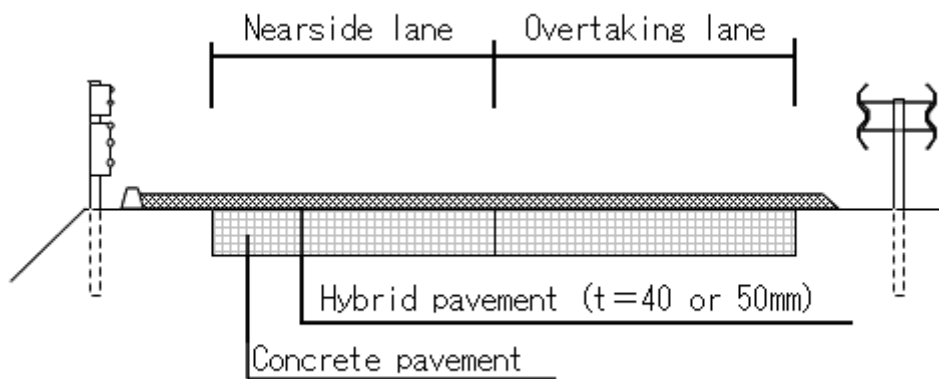
Figure 15: Diagrammatic illustration of thickness of pavement

Four centimeter of thickness appropriates for hybrid pavement in general. However, various types of thickness of hybrid pavements were tested so that the optimum thickness and durability of the pavement and aging of reflective cracking was needed to confirm. Overlay for four or five centimeter of thickness and five centimeter after milling one centimeter concrete pavement were executed by this follow-up (Figure 15).

As a result of the follow-up, there are no changes of the surface property and damages by reflective cracking between four and five centimeters of thickness.

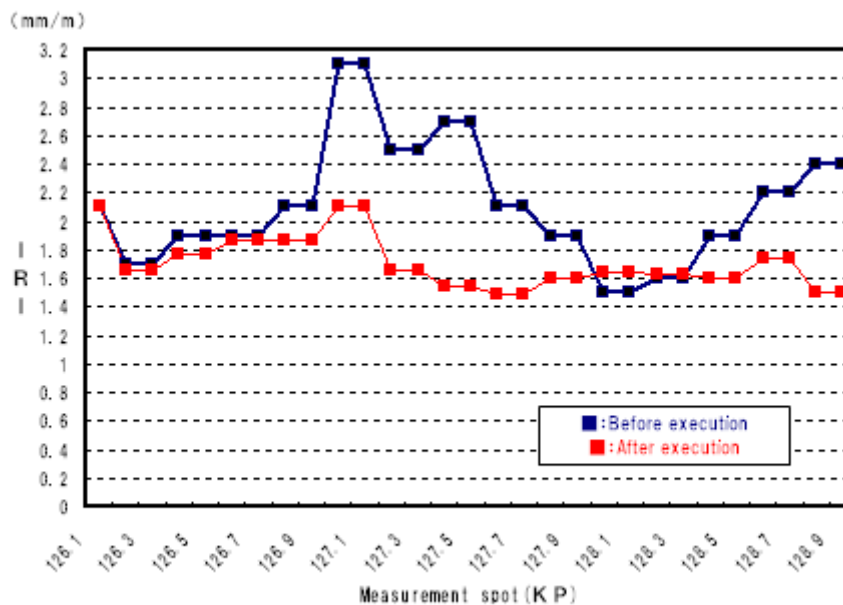
Figure 16: Examination execution result (IRI)

Figure 16 shows the IRI improves the average from 2.1mm/m to 1.7mm/m. However there remains wobble vibration at the joints by the major impact of thin thickness of hybrid pavement.

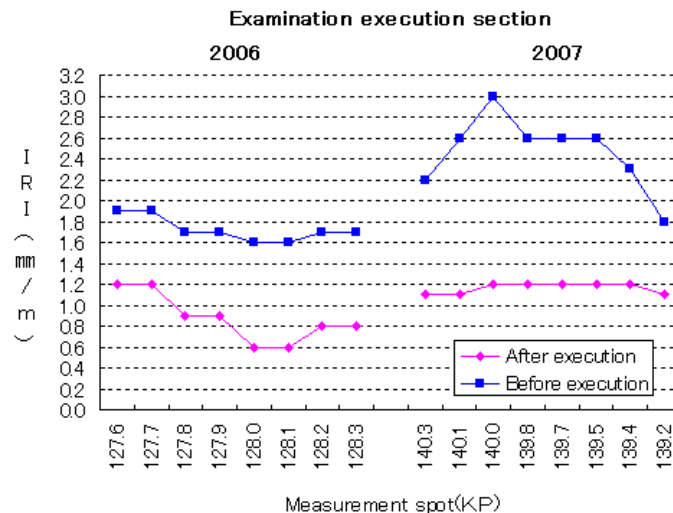
Figure 17: Execution result of 2006 .2007 year (IRI)

Figure 17 shows the result of IRI after the execution.

Homogeneous result was confirmed in about the execution in 2007, although there seemed unevenness on IRI value because of the impact of differences in level of existing concrete pavement. by the examination execution of 2006
